**Flood Control Project Maintenance
Levee Inspections**

Maintenance Issue Types Only, Levee Inspection Report By Mile - Fall 2018

Reclamation District No. 2085 Kasson

Waterway	Bank	Unit Miles	Inspection Start/End	Inspector
Unit No. 01 San Joaquin River	Left	5.29	11/01/2018 11/01/2018	Zach Jojola

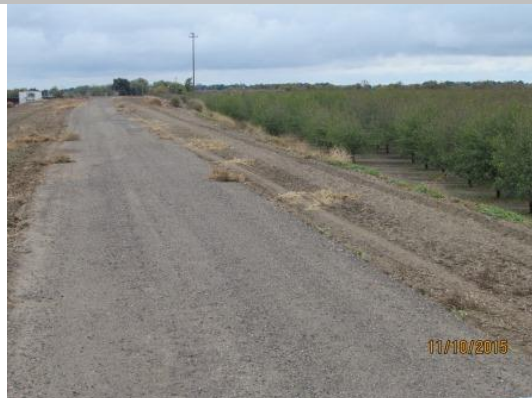
Photo 1 of 1 : FA_2018_RD2085_113_19_20180911_00011.jpg

LM Start	0.12	Rating **	A/W	Issue No.	19
LM End	0.47	Issue Type +	Ma	Location *	CR
Category	Earthen Levee			GPS Latitude/Longitude	
				Start	End
Item	Crown Surface / Depressions / Rutting			37.719052 °	37.723246 °
				-121.302928 °	-121.299492 °
DWR ID	DWR_RD2085_01_f_2015_19				
Comment Code					
C1 : Add appropriate material and re-grade the levee to bring the crown above the design elevation.					
Inspector Comment					
Disking on the levee shoulder. Make sure the water drains evenly to the slopes.

View of the disking on the levee crown shoulder.

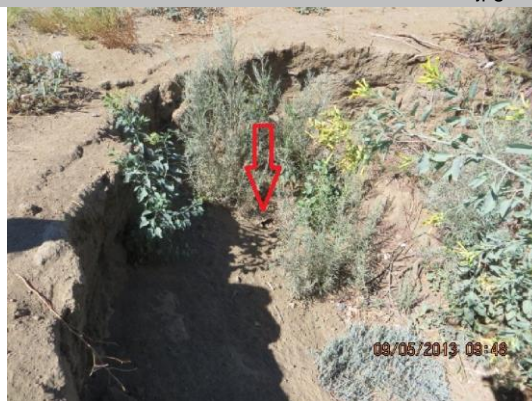
Photo 1 of 3 : UCIP_FA_2018_52493_62262.jpg

Comment Code					
Inspector Comment					
FS_ID:52493 DS_ID:20677 EP_NO: N/A Repair Type: No Action Needed Crossing Status: Found UCIP Comments: Pipe has been removed by LMA.Previous:Pipe abandoned. Erosion around pipe on WS slope. Pipe severely corroded. Pier badly damaged. FIELD_STRUCT_DESC: *REMOVED* 14-inch steel drainage pipe through the levee, 4.5 feet below the crown. Pump on pile structure in ditch on the landside (LS). Siphon breaker in corrugated metal pipe (CMP) riser on the waterside (WS) shoulder. Pipe removed by LMA. (Permit Application No. T2013179, 2014 - Surinder Sandhu, submitted to CVFPB. Permit was not needed per CVFPB review). [Additional Reference(s): DWR Levee Log, 2005. USACE San Joaquin O&M Manual 11, 1968, (HLM 0.47)]. FS Date: 9/5/2013

(Pipe removed by LMA)Pipe on WS with erosion into levee slope.

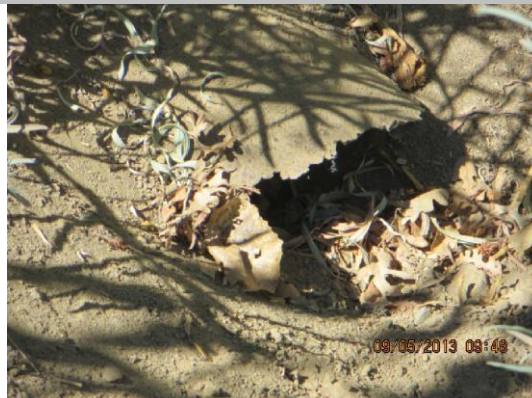
Photo 2 of 3 : UCIP_FA_2018_52493_62261.jpg

Pipe removed from WS toe.

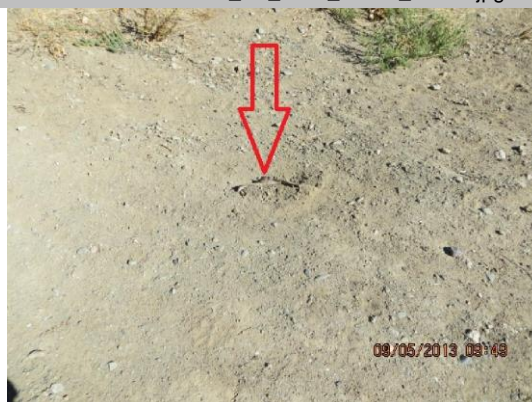
Photo 3 of 3 : UCIP_FA_2018_52493_62260.jpg

Siphon breaker in 24-inch CMP riser on WS shoulder was removed by LMA.

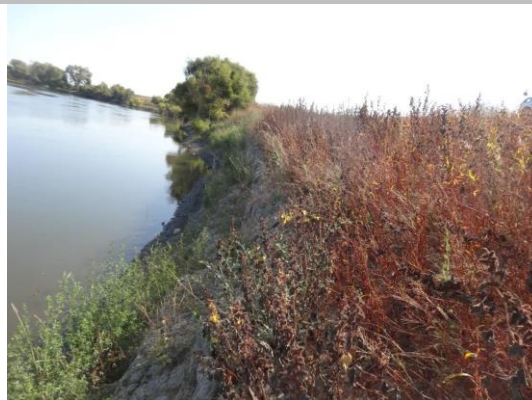
Photo 1 of 4 : FA_2018_RD2085_113_1_20180911_00001.jpg

LM Start	1.15	Rating **	M	Issue No.	1
LM End	1.26	Issue Type +	Ma	Location *	WS
Category	Supplemental			GPS Latitude/Longitude	
				Start	End
Item	DWR Erosion Survey			37.715996 °	37.715996 °
				-121.291229 °	-121.291229 °
DWR ID	RD2085U01RM62.43				
Comment Code					
Inspector Comment					
11/02/2017: The erosion was reported to DWR by LMA. The site is located at the outside of a slight river bend. Both levee slope and river bank are covered with dense vegetation. [2017 Site ID:RD2085U01RM62.43]

Looking upstream at the erosion site. Note the dense vegetation and the trees at the upstream of the erosion.

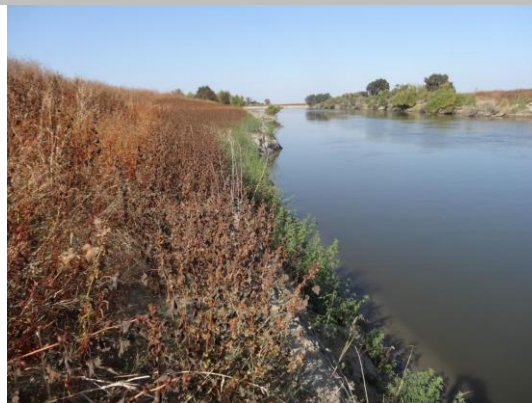
Photo 2 of 4 : FA_2018_RD2085_113_1_20180911_00002.jpg

Looking downstream at the erosion site.

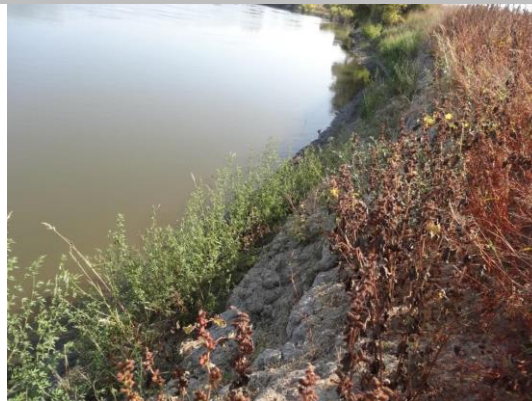
Photo 3 of 4 : FA_2018_RD2085_113_1_20180911_00003.jpg

Close view of the erosion.

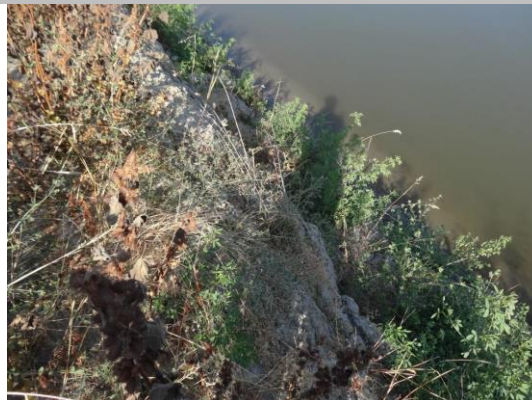
Photo 4 of 4 : FA_2018_RD2085_113_1_20180911_00004.jpg

Close view of the erosion.

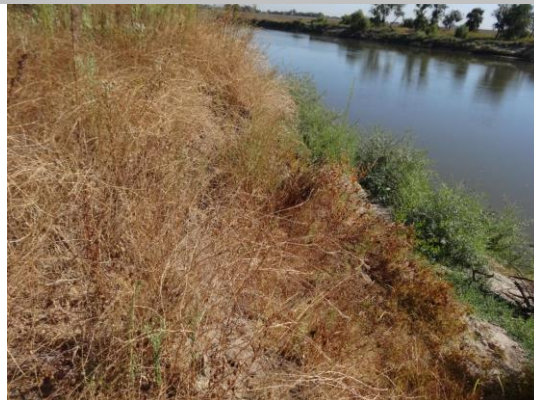
Photo 1 of 4 : FA_2018_RD2085_113_2_20180911_00005.jpg

Comment Code					
Inspector Comment					
11/1/2018: This site was repaired within the past week.					
10/04/2017: The erosion has progressed significantly toward the levee toe.					
07/08/2016: No significant change observed.					
09/10/2015: No significant change observed. Signs of animal activity are present.					
09/10/2014: No significant change observed.					
09/20/2013: No significant change in erosion observed. More vegetation at the site.					
12/04/2012: The erosion has progressed remarkably toward levee, extended to the up-and downstream of the original pocket erosion. Trees and dense bush are present at the site. Animal burrow holes are visible, and possibly can cause seepage.					
09/22/2010: No significant change observed. There is little visibility due to seasonal grass on the berm and slope.					
08/18/2009: Site is located on berm; pocket erosion has developed; the site is covered in dense vegetation; there are several relief wells on the landside of the levee; site is Not Rated because berm width is greater than 30 feet; site should be monitored to keep track of erosion progress. [2017 Site ID:RD2085U01RM66.5]

Close view of the erosion. Note the dense vegetation at the site.

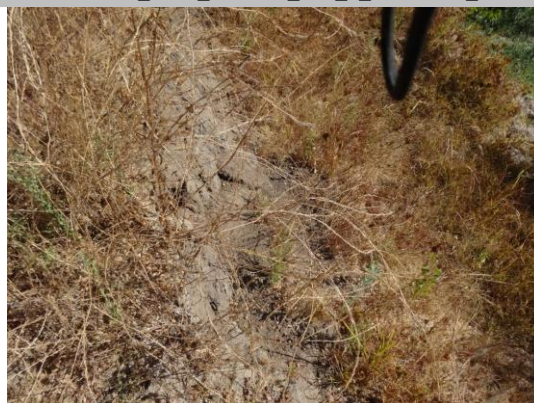
Photo 2 of 4 : FA_2018_RD2085_113_2_20180911_00006.jpg

Close view of the erosion.

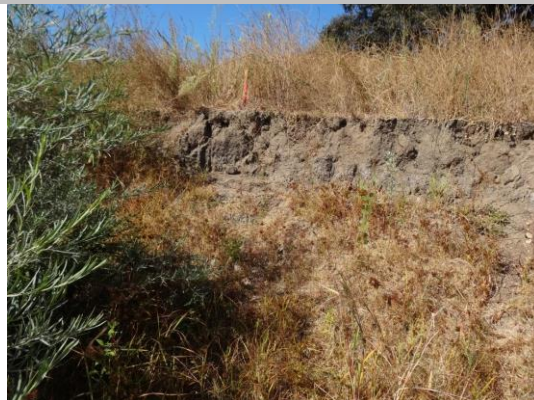
Photo 3 of 4 : FA_2018_RD2085_113_2_20180911_00007.jpg

11/1/2018: This site was repaired within the past week.
 10/04/2017: The erosion has progressed significantly toward the levee toe.
 07/08/2016: No significant change observed.
 09/10/2015: No significant change observed. Signs of animal activity are present.
 09/10/2014: No significant change observed.
 09/20/2013: No significant change in erosion observed. More vegetation at the site.
 12/04/2012: The erosion has progressed remarkably toward levee, extended to the up-and downstream of the original pocket erosion. Trees and dense bush are present at the site. Animal burrow holes are visible, and possibly can cause seepage.
 09/22/2010: No significant change observed. There is little visibility due to seasonal grass on the berm and slope.
 08/18/2009: Site is located on berm; pocket erosion has developed; the site is covered in dense vegetation; there are several relief wells on the landside of the levee; site is Not Rated because berm width is greater than 30 feet; site should be monitored to keep track of erosion progress. [2017 Site ID:RD2085U01RM66.5]

Direct view of the erosion. Note the sign of erosion expansion.

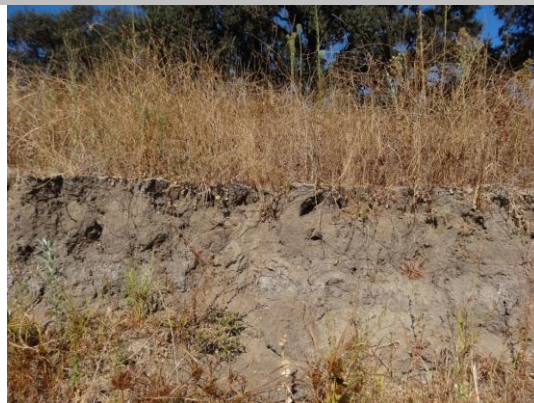
Photo 4 of 4 : FA_2018_RD2085_113_2_20180911_00008.jpg

Close view of the erosion.

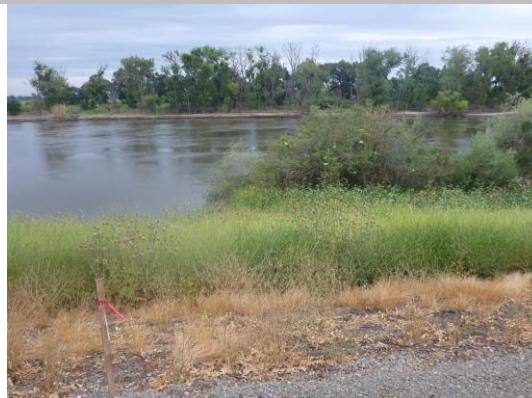
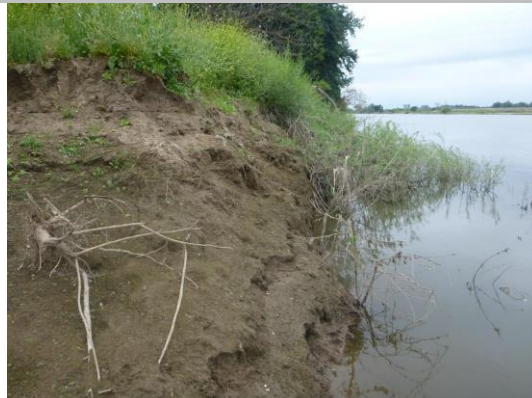
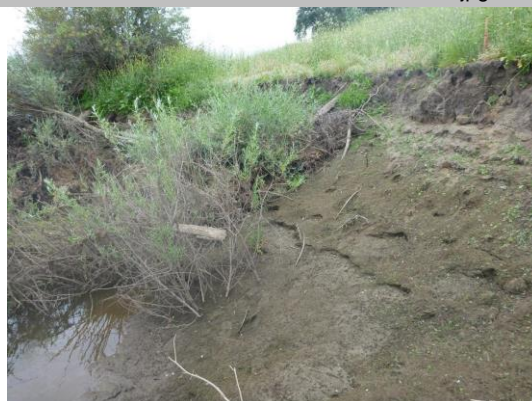
LM Start	2.57	Rating **	A/W	Issue No.	48	
LM End		Issue Type +	Ma	Location *		
Category	Supplemental			GPS Latitude/Longitude		
				Start	End	
Item	2017 Storm Damage			37.703094 °		°
				-121.274894 °		°
DWR ID	DWR_RD2085_01_f _ 2017_48					
Comment Code						
Inspector Comment						
Levee Evaluation Comments						
Description:						
Site ID No:105						
Site Designation:FSRP-13-55						
Repair Type: Erosion						
Rating:Serious						
Field Date:6/8/2017						
Notes: This site is repaired as of this inspection date. Fall 2018.

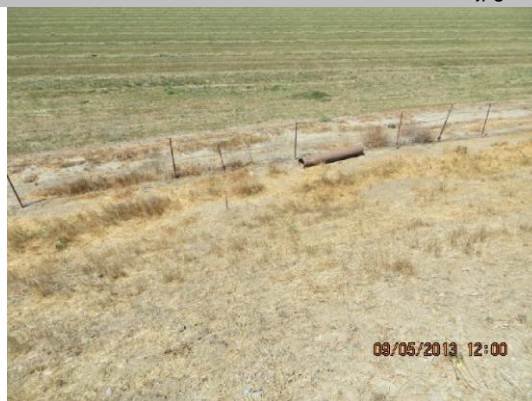
Photo 1 of 3 : UCIP_FA_2018_19433_32990.jpg

LM Start	3.30	Rating **	M	Issue No.	57	
LM End	3.30	Issue Type +	Ma	Location *		
Category	Supplemental			GPS Latitude/Longitude		
				Start		End
Item	DWR UCIP LMA Responsibility			37.693618 °	37.693618 °	
				-121.277639 °	-121.277639 °	
DWR ID	20693					
Comment Code						
Inspector Comment						
FS_ID:19433 DS_ID:20693 EP_NO: N/A Repair Type: Non-Urgent Crossing Status: Found UCIP Comments: Pipe appears abandoned and should be done so properly. FIELD_STRUCT_DESC: *ABANDONED* 10-inch steel storm drainage pipe through the levee, 4 feet below the crown. T-post marks location of pipe at the landside (LS) toe. Steel plate welded over pipe on the waterside (WS) slope. [Additional Reference(s): USACE San Joaquin O&M Manual 11, 1968, (HLM 3.34), As-Built Drawings available, DWG 7-4-1685]. FS Date: 9/5/2013

T-post marking pipe end on LS toe. 10-inch pipe debris on LS toe.

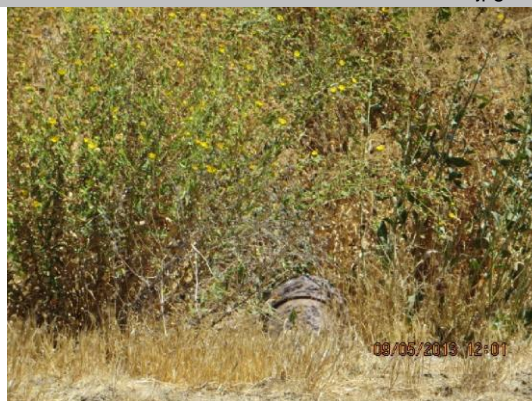
Photo 2 of 3 : UCIP_FA_2018_19433_32989.jpg

Pipe visible on WS slope.

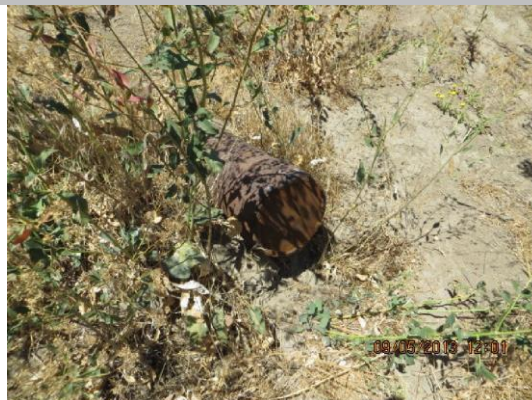
Photo 3 of 3 : UCIP_FA_2018_19433_32988.jpg

Pipe visible on WS slope. Steel plate welded over end.

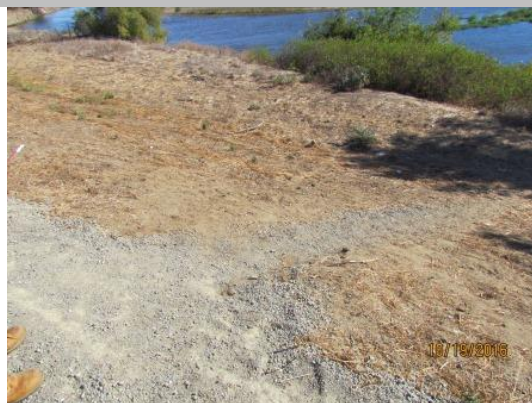
Photo 1 of 1 : FA_2018_RD2085_113_26_20180911_00014.jpg

LM Start	3.74	Rating **	A/W	Issue No.	26
LM End	3.74	Issue Type +	Ma	Location *	WS
Category	Earthen Levee			GPS Latitude/Longitude	
				Start	End
Item	Slope Stability			37.687841 °	37.687841 °
				-121.276678 °	-121.276678 °
DWR ID	DWR_RD2085_01_f_2015_26				
Comment Code					
S2 : Repair the levee slope damaged by foot traffic and prevent access where possible.					
Inspector Comment					
Area should be maintained to prevent further levee damage.

View of the foot path on the levee slope.

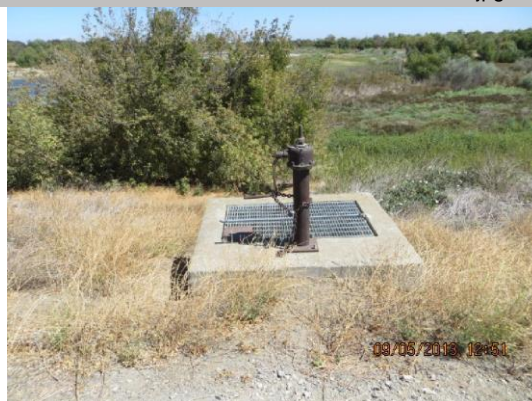
Photo 1 of 3 : UCIP_FA_2018_19436_32997.jpg

Slide gate in Concrete riser on WS shoulder.

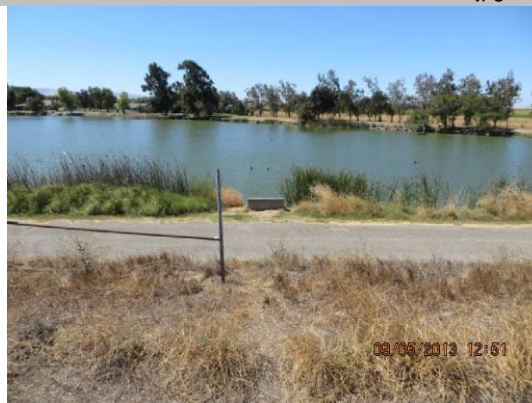
Photo 2 of 3 : UCIP_FA_2018_19436_32996.jpg

Concrete headwall off LS toe.

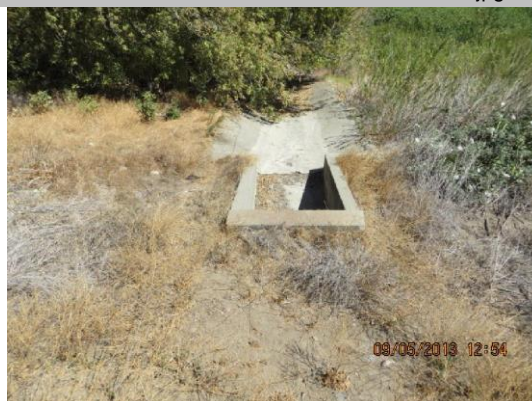
Photo 3 of 3 : UCIP_FA_2018_19436_32995.jpg

Concrete U-shaped headwall on WS slope.

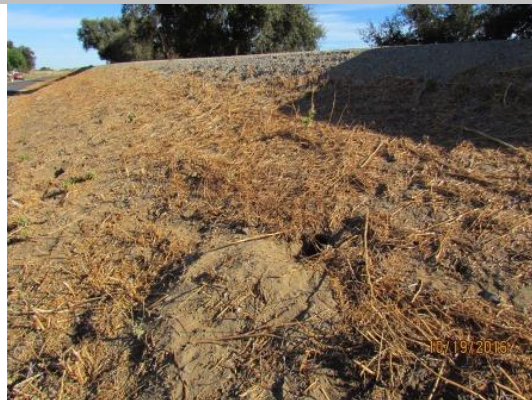
Photo 1 of 1 : FA_2018_RD2085_113_36_20180911_00022.jpg

LM Start	3.86	Rating **	A/W	Issue No.	36
LM End	3.91	Issue Type +	Ma	Location *	LS
Category	Earthen Levee			GPS Latitude/Longitude	
				Start	End
Item	Animal Control			37.686059 °	37.685340 °
				-121.276745 °	-121.276594 °
DWR ID	DWR_RD2085_01_f_2016_36				
Comment Code					
A3 : No rodents visible, but rodent burrows visible; need to backfill and compact or grout burrows.					
Inspector Comment					
Area should be monitored for possible rodent activity.

View of the rodent holes on the levee slope.

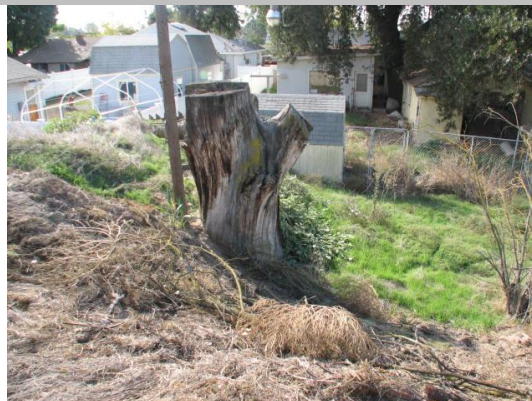
Photo 1 of 1 : FA_2018_RD2085_113_32_20180911_00018.jpg

11/03/2011 Large stump on landside slope.

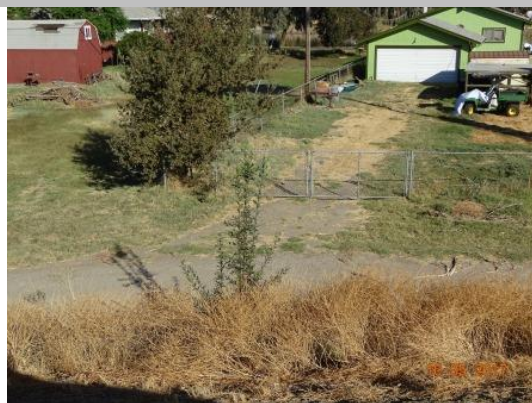
Photo 1 of 1 : FA_2018_RD2085_113_3_20180911_00009.jpg

LM Start	5.04	Rating **	A/W	Issue No.	3
LM End	5.04	Issue Type +	Ma	Location *	LS
Category	Earthen Levee			GPS Latitude/Longitude	
				Start	End
Item	Vegetation			37.677735°	37.677735°
				-121.269132°	-121.269132°
DWR ID	DWR_RD2085_01_f_2017_3				
Comment Code					
V7 : Trees / Woody Vegetation					
Inspector Comment					
Recommend removing volunteer tree.

View of the volunteer tree at the levee toe.

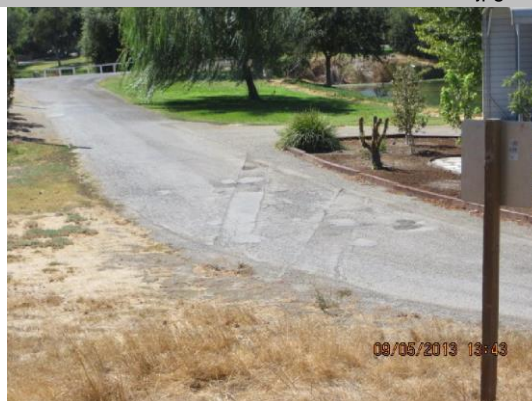
Photo 1 of 3 : UCIP_FA_2018_23060_39184.jpg

Cuts in pavement off LS toe good indicator of pipe location.

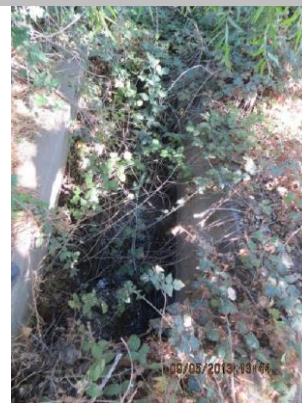
Photo 2 of 3 : UCIP_FA_2018_23060_39183.jpg

Concrete U-shaped headwall visible on WS toe.

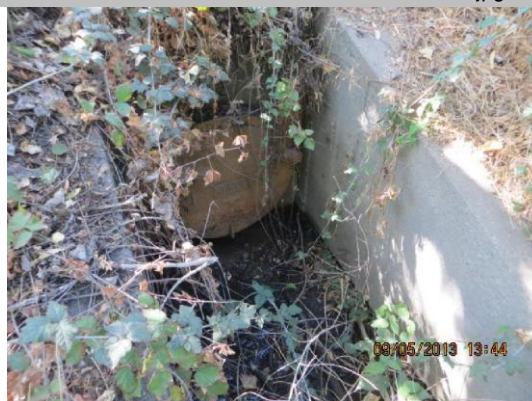
Photo 3 of 3 : UCIP_FA_2018_23060_39182.jpg

Concrete U-shaped headwall and flapgate visible on WS toe.

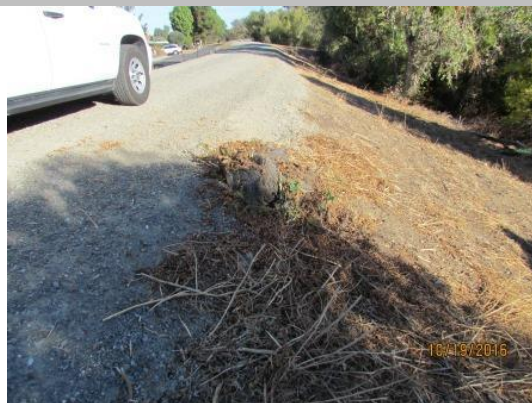
Photo 1 of 1 : FA_2018_RD2085_113_29_20180911_00017.jpg

LM Start	5.24	Rating **	N	Issue No.	29
LM End	5.24	Issue Type +	Ma	Location *	WS
Category	Earthen Levee			GPS Latitude/Longitude	
				Start	End
Item	Trim / Thin Trees			37.675099°	37.675099°
				-121.269264°	-121.269264°
DWR ID	DWR_RD2085_01_f_2015_29				
Comment Code					
T5 : Tree stumps.					
Inspector Comment

View of the tree stump.

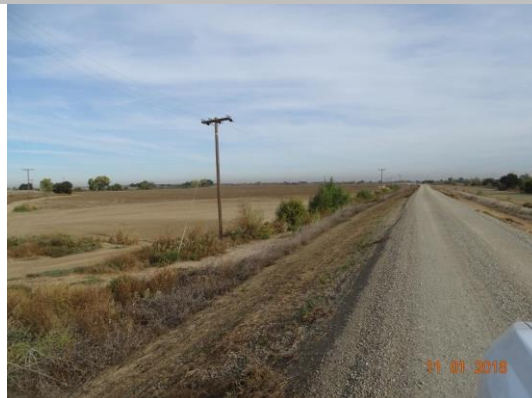
Photo 1 of 1 : FA_2018_RD2085_114_1_20181105_00001.jpg

View of maintained waterside slope. Fall 2018.

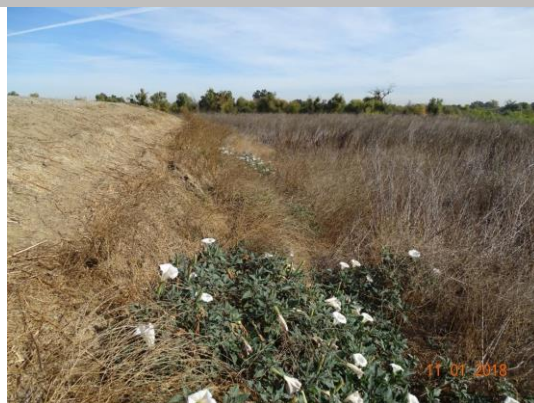
Photo 1 of 4 : FA_2018_RD2085_115_1_20181105_00004.jpg

LM Start	0.21	Rating **	U	Issue No.	1
LM End	0.23	Issue Type +	Ma	Location *	WS
Category	Earthen Levee			GPS Latitude/Longitude	
				Start	End
Item	Erosion / Bank Caving			37.682798°	37.683052°
				-121.262059°	-121.261851°
DWR ID	DWR_RD2085_03_s_2014_1				
Comment Code					
E2 : Schedule repair of erosion site prior to the next inspection.					
Inspector Comment					
Erosion of the waterside levee slope has been observed. The erosion is about 3 feet tall vertical from the slope to the base of projected levee toe.

Updated view of erosion on the waterside slope. Fall 2018.

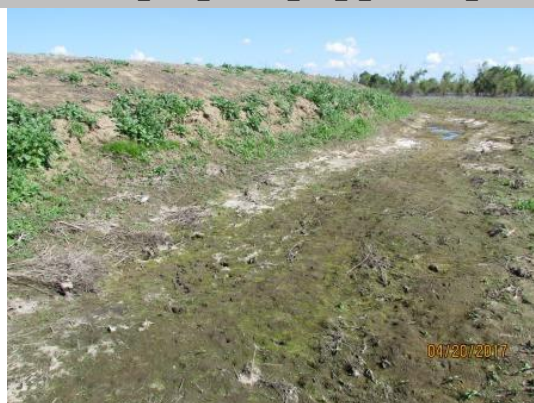
Photo 2 of 4 : FA_2018_RD2085_115_1_20180911_00001.jpg

View of the erosion at the waterside levee toe. Spring 2017.

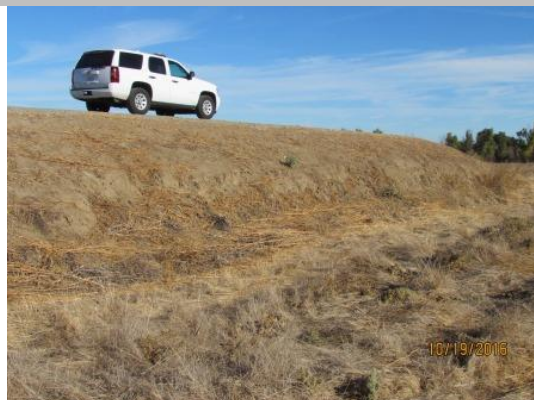
Photo 3 of 4 : FA_2018_RD2085_115_1_20180911_00002.jpg

View of the erosion at the waterside levee toe. Fall 2016.

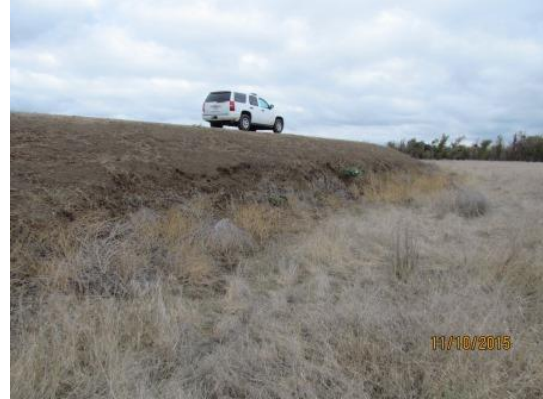
Photo 4 of 4 : FA_2018_RD2085_115_1_20180911_00003.jpg

View of the erosion at the waterside levee toe.
